GEOMEMBRANE WAVE PROPAGATION MANAGEMENT & SCORING

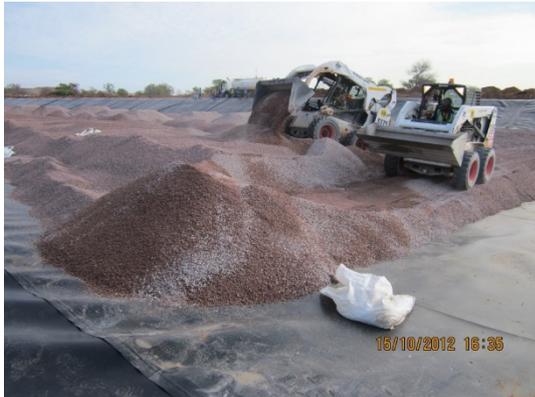
FIGURE 1

To illustrate you are referred to a photograph taken clearly showing the "scoring" (Fig. 2) as a result of the distribution method of the aggregate by "skidsteers" with "low ground pressures" (Fig. 1) Evidently this creates a "push/accumulate/cut/seam" which is commonly practised to speed up production, this obviously places even further induced stress on the particular geomembrane / geosynthetic and risk of occurrence is elevated. This is further exacerbated by the placement of aggregate directly in contact with a geomembrane as can be seen in (Fig. 1). Many sites inspected revealed "scoring" of the top surface of the Geomembrane directly ascribed to aggregate placement by mechanical means. This action is very similar to the induced action of technician practices during panel placement.

It is important to note the angle of the "skidsteer" in (Fig. 1), this practice will most decidedly induce "scoring" of the geomembrane. Forensic work into several applications revealed an abundance of top surface "scoring" and the conclusion of the investigative team was that this was a contributing factor to the general failure of the membrane.

The point here is simply that the exclusion of protective geosynthetics below and above geomembranes must be approached with circumspection and the resultant cost savings must be compared to the increased risk of failure, which might not be a risk but possibly a given. Duty of care must be properly documented by both engineer and contractor when dealing with "budget" specifications to mitigate and reduce unnecessary "scoring" including proper aggregate distribution to minimize any unwanted waves / wrinkles and / or management thereof.
